Clinical Realities

IMPLANT NEWSLETTER FOR CLINICIANS

From the treatment records of Paul P. Binon DDS, MSD

CASE OF THE MONTH

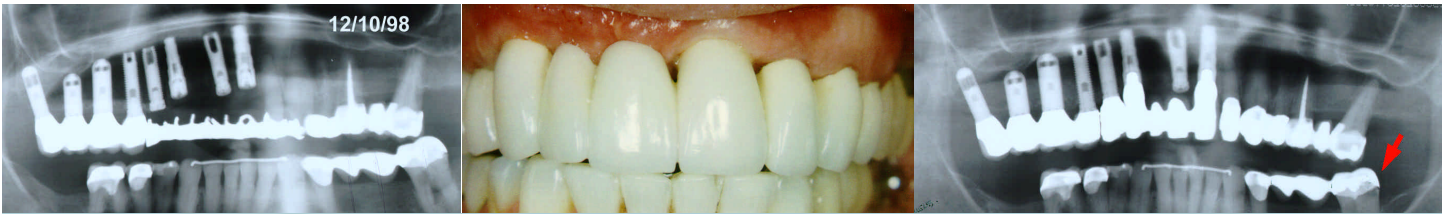
FOUR ADDITIONAL IMPLANTS PLACED AND BONE DEFECTS GRAFTED
NEW PROVISION USING NATURAL AND IMPLANT SUPPORT IN PLACE 6 MONTHS
FAILING MOLAR, SEGMENT REPLACED WITH THREE IMPLANTS

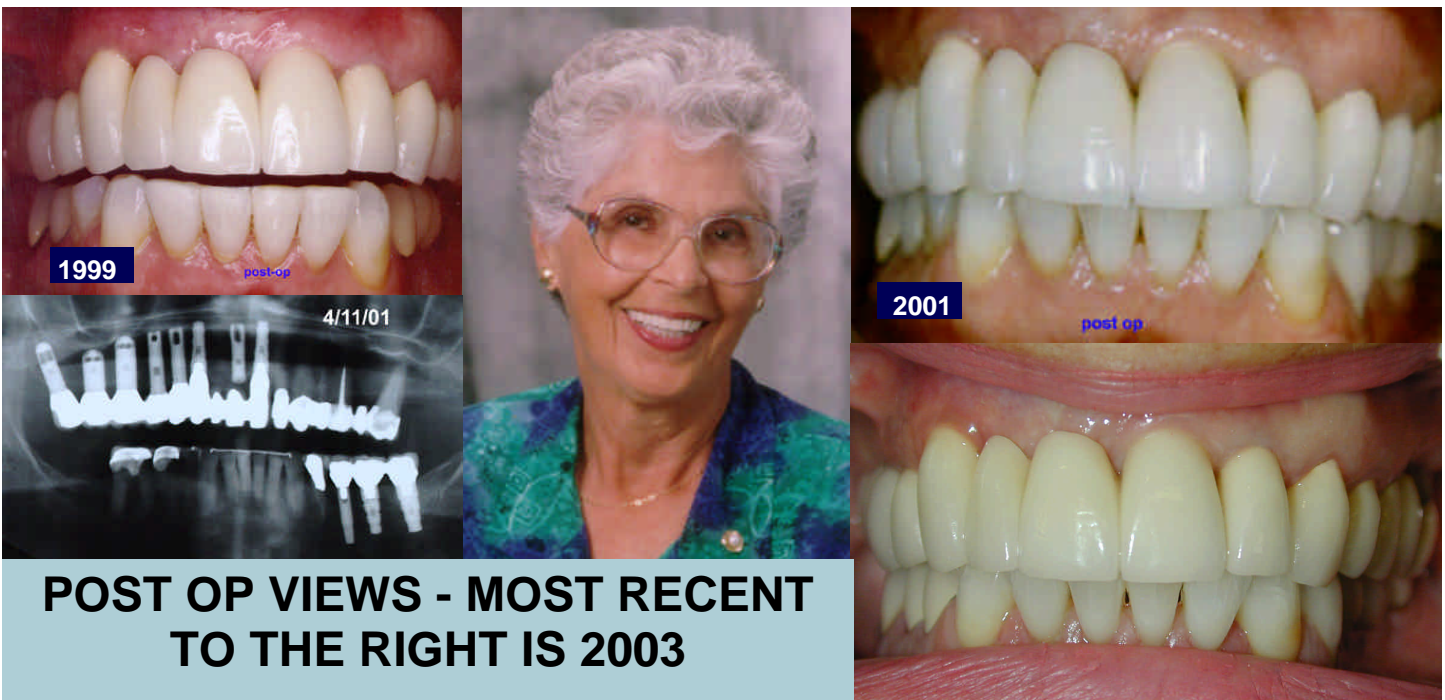
POST OP VIEWS - MOST RECENT TO THE RIGHT IS 2003

As soon as the maxillary treatment was near completion, three additional implants were placed in the lower left quadrant. The upper arch was restored with two independent implant segments and PFMs on 10 and 11. After three and a half months, custom abutments and PFM crowns were made and inserted on the lower implants. Maxillary and mandibular treatment was completed in 1999. Patient is highly motivated and her home care is excellent. The soft tissues have regenerated very well in the proximal areas of 8, 9, and 10. In general, bone type was Type II or III. All implants were greater than 10 mm in length (most were 15 mm) and ranged in diameter from 3.75 mm to 5.5 mm. Post operative healing was uneventful during all procedures. Sequential post op photos illustrate excellent esthetic and functional result.

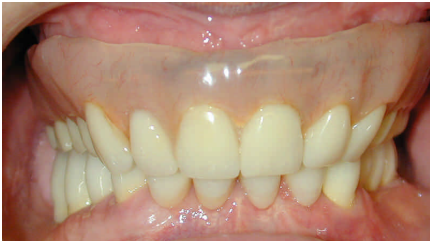
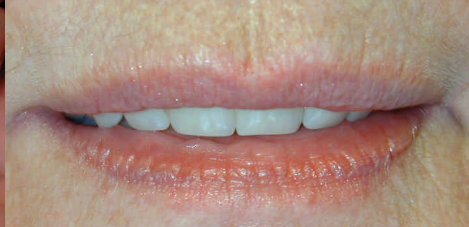
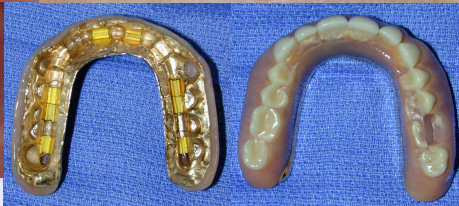
RECALL VIEWS 2003

SIGNIFICANT WEAR OF DENTURE TEETH AND SLIGHT LOSS OF VD OVER 10 YEAR PERIOD WILL NECESSITATE REPROCESS OF DENTURE

ment has functioned for 10 years. Bone levels on the lower natural teeth and the upper implants has not changed during that time. The cuspid site implants are sleeper that support the corners of the dental arch and have not and will not be loaded. Patient is seen once a year in my office and at 6 months intervals by a periodontist in Las Vegas, Nevada.

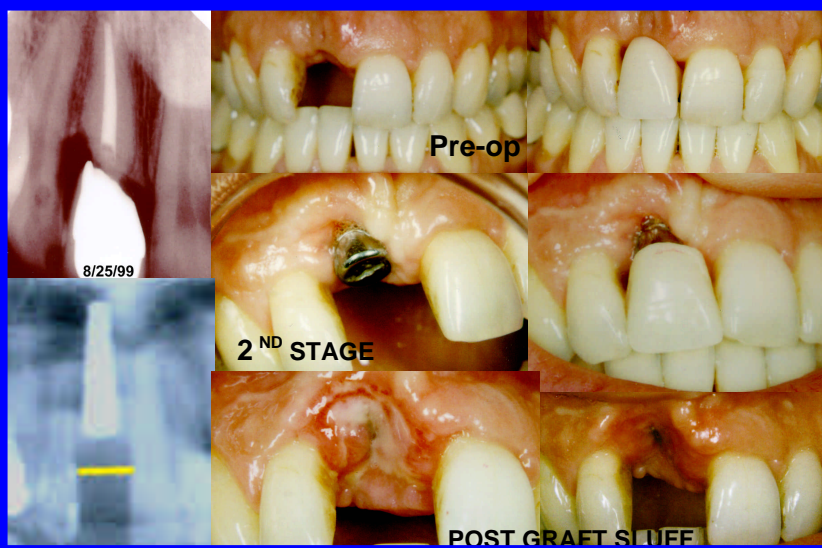
In April of 2000 a patient relocating from the Bay Area was referred to complete her implant treatment. Number 8 had a horizontal fracture with advanced labial bone loss and had been extracted the previous month. The Bay area surgeon had removed the root and completed a socket and labial surface graft. Care was transferred to a local surgeon who placed a veneer graft in September. Approximately four months later, a 2 mm area of the veneer cortex was exposed and debrided. The implant was inserted approximately 3 months later. At the time of implant placement, the graft had matured quite well however, there was still a slight vertical height and labial width insufficiency. The implant was inserted to the level of the labial bone crest. At second stage, some problems became apparent: insufficient bone labially to support soft tissue (indented area); implant exit trajectory; and a significant frenum pull. The second stage photos indicate that with diligence, the problems were still manageable.

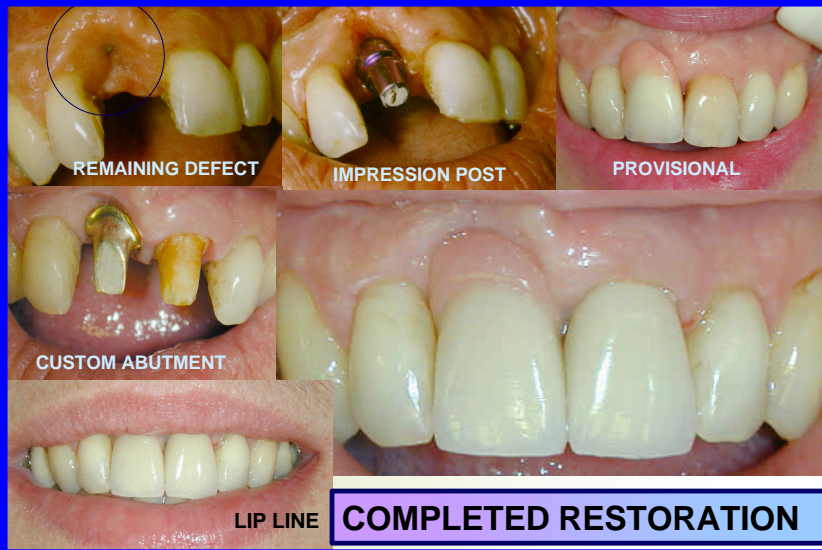
In an effort to correct the soft tissue disharmony a gingivectomy and gingioplasty was performed at the end of May. The tissues were still not esthetically acceptable due to dehiscence and at the end of July a soft tissue graft (Alloderm) and Bio-Oss graft was attempted. Unfortunately the graft sluffed and the resulting defect was even larger than the original. Additional interproximal papillae was lost on both sides. The remaining defect was left to completely heal and mature for approximately six months. An impression was made and a provisional restoration was also placed during this time. A prefabricated titanium abutment was used to support the provisional crown. During the maturation period, #9 became symptomatic and was diagnosed with irreversible pulpitis. This was coincidental and unrelated to implant treatment.

Once the tissues had stabilized, a custom cast abutment was made for # 8 and # 9 was pre-prepared for a PFM crown. The porcelain fused to metal restorations were inserted and esthetics was restored. The result was pleasing to the patient, the surgeon and myself.

Needless to say, all concerned had some difficult times during this course of treatment. In retrospect, alteration of the treatment plan could have changed the outcome. I believe that if a larger onlay graft had been used initially, the defect may have been avoided. Subsequent surgeries would then have also been avoided. A critical factor in the surgical outcome was that the patient was a very smoker. That contributed to the **microvascular compromise** and the
