Clinical Realities

SPRING 2006

IMPLANT NEWSLETTER FOR CLINICIANS

**FAILURE !
SECURING A SOLUTION**

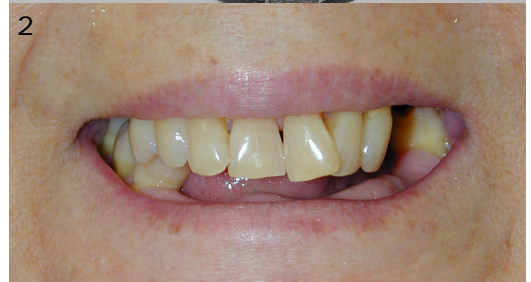
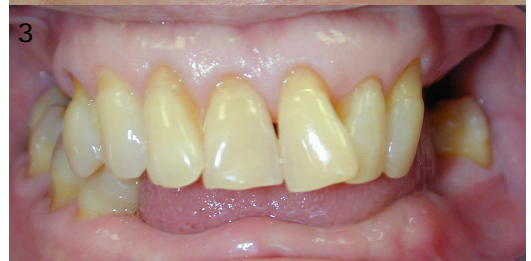
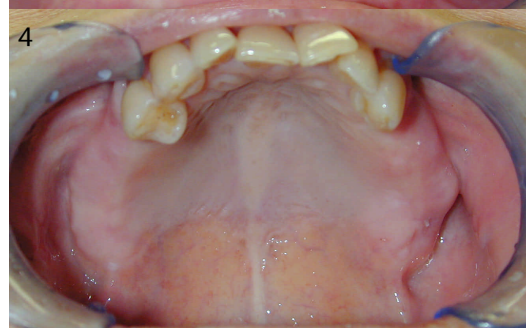
Multiple treatment options for both dental arches involving implant and non implant supported prosthesis apply to this patient's situation and were considered. Conventional treatment in the upper arch was selected that consisted of splinted crowns on 5 & 6 and a single crown on 11. Both 5 and 11 had Mini Dalbo attachments and distal and lingual guide planes for a precision RPD with an anterior palatal strap. The attachments allowed for lateral stability and a rotational hinge to minimize the stress on the abutment teeth. The design also allowed for a progressive level of treatment, if additional stability was

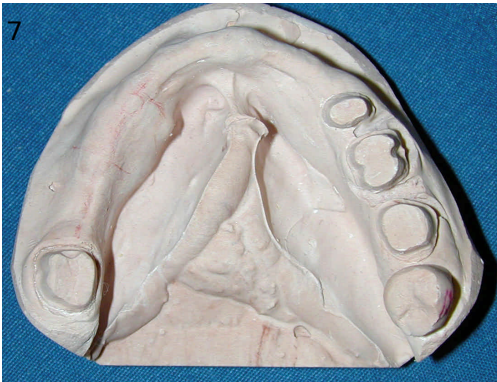
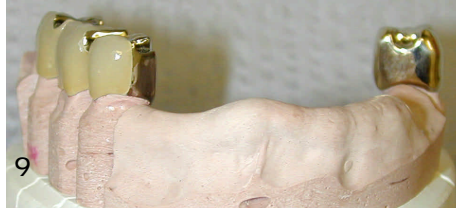
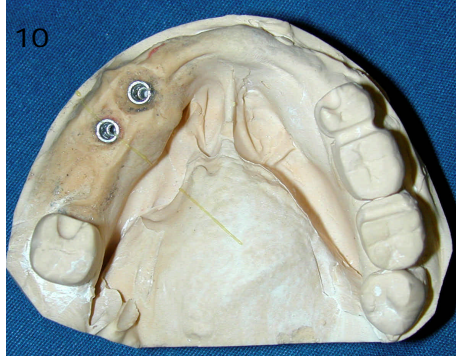
A variety of treatment options could be applied to the lower arch depending on patient expectations and economic considerations. Since a removable prosthesis offered significant economic advantages, the remaining posterior teeth would have to be modified to properly support and stabilize the projected RPD. Furthermore, the loss of VD due to occlusal attrition could be rebuilt and, at the same time, adequate inter-arch space could be regained.

Additional support in the left sextant, to avoid rotational dislodgment of the prosthesis, was definitely necessary. The treatment plan of choice was as follows: Crowns on 18, 29, 30 and 31 with appropriate guide planes, rests and clasp retention undercuts, the placement of two implants in locations 20 and 22. This location was ideal due to the presence of the large tori. It allowed placement of 3.4 Xive implants of 15 and 11 mm respectively. The implants would be restored with a custom bar and two Locator attachments that could provide up to 10 Lbs of retention and excellent lateral stability. Treatment sequence was as follows: 1) Maxillary preps on 5, 6 and 11.

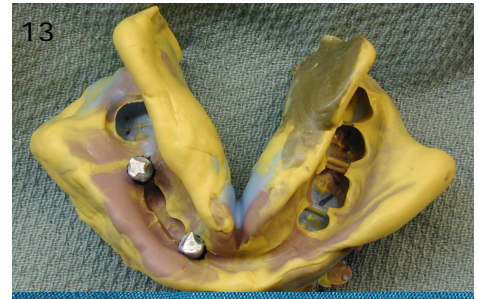
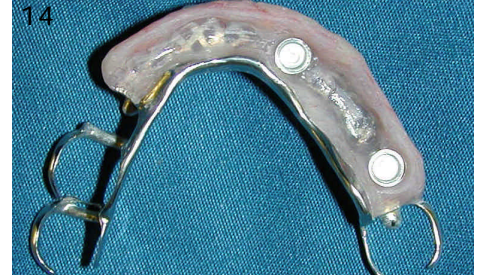
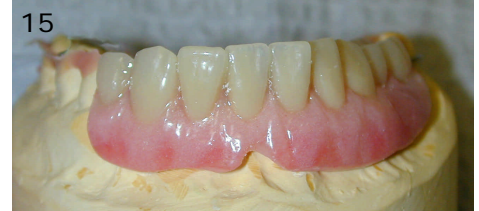
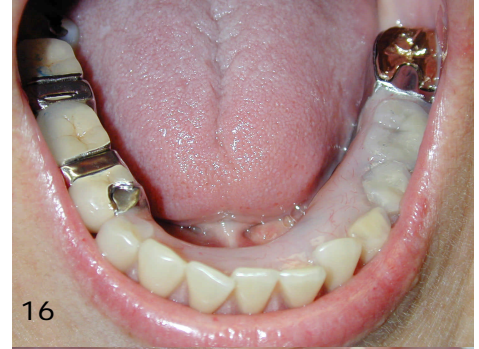
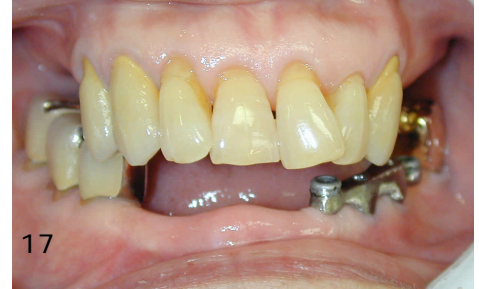
COMPLETED TREATMENT

The patient has been pleased with the stability, retention, functionality and esthetics of the prosthetic treatment provided. At the present time only one Locator retention cup is active. Key elements to success were an innovative treatment plan, appropriate design of the partial denture support and retention elements and, utilization of the proper number and location of dental implants. Biomechanics are critical when implementing an implant treatment plan.

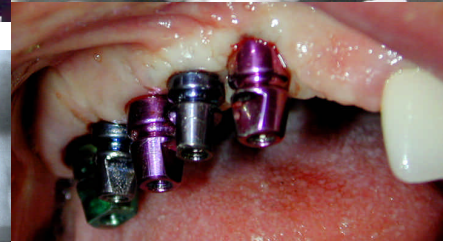
At second stage, a new FPD was constructed, using the 5 implants.

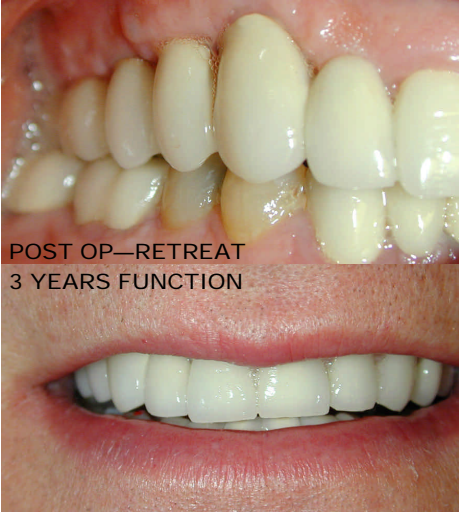
So, what were the reasons for failure in this case? **Delayed** failure appears not to be unusual with this implant although two of the 3 originally placed implants demonstrated no bone loss and functioned quite well during re-treatment.

Analyzing the reasons for an implant failure range from the very obvious to mere speculation especially when everything was done correctly. First, was it overload? Unlikely because the spacing was ideal, the implants were long (13 & 15mm) and with wide platforms (5.5 & 6.5mm). The CT scan showed adequate bone volume to support the size of these implants. Right from the start I ruled out overload since the remaining two implants demonstrated no bone loss and continued to support the original fixed bridge during the grafting and implant replacement sequence with no ill effects.

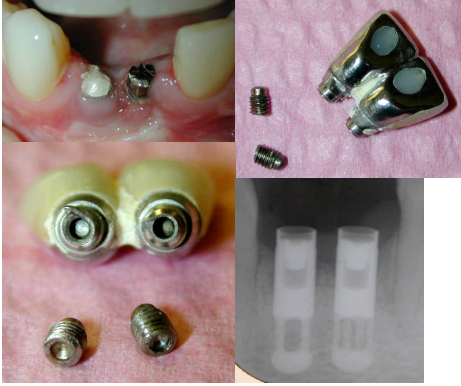
These **IMZ** implants located in # 25 and 26 sites, had been in function for 10+ years. They were restored with **splinted** screw retained PFM's. Unique to this case was that the typical system IME (intra-mobile element) or the titanium intermediate element were not used. Most likely because of the frequent problems and maintenance headaches encountered with these components. Instead, after market components were used to restore the case. These large "conversion" abutments fractured while the "prosthetic" retaining screws remained intact. The "fix" was easy. Measure the gingival collar

and order replacement parts from 3i. Spinning out the screw ends was the challenge. If you damage the threads, inside the implant, its irreversible. Here, the same crowns could be replaced and the patient was happy.
